## REPORT

### RETROUT study visit in Estonia

September 18-19, 2019

North-Estonia

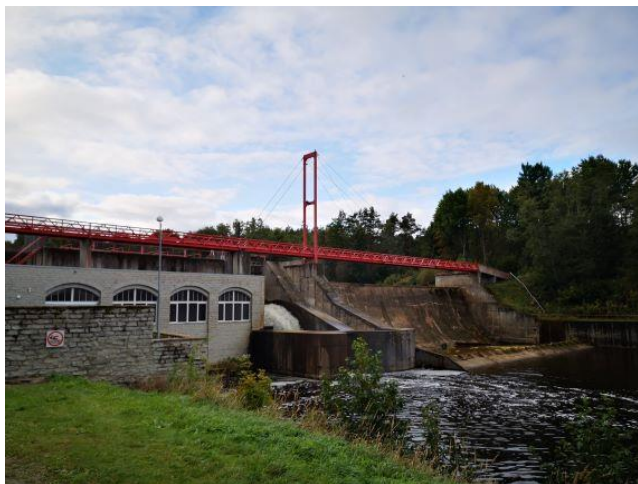
Linnamäe is the most powerful hydro-electric power station in Estonia. Characteristics: height 11 m, capacity 1.1 MW. There is no fish pass and it is deemed as a culturally valuable site.

The dam lost its water permit in August 2019 and the obligation to provide fish passage stands.

Photo 1. Linnamäe hydropower station (S. Oisalu)

*Discussion on the site:* the main discussion on the site was related to conflicting interests regarding the site. Part of the dam was classified as culturally valuable and therefore optimal solutions for fish passage are hard to achieve.

RETROUT project will provide plans how to remove the dam in a way that the cultural value is least affected. This work is currently in process.

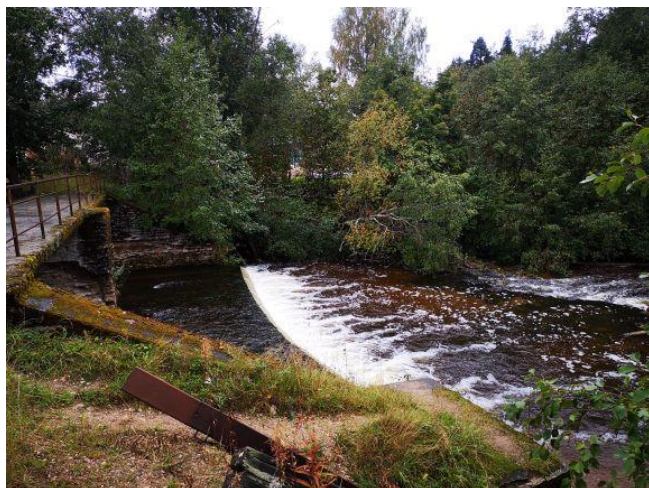
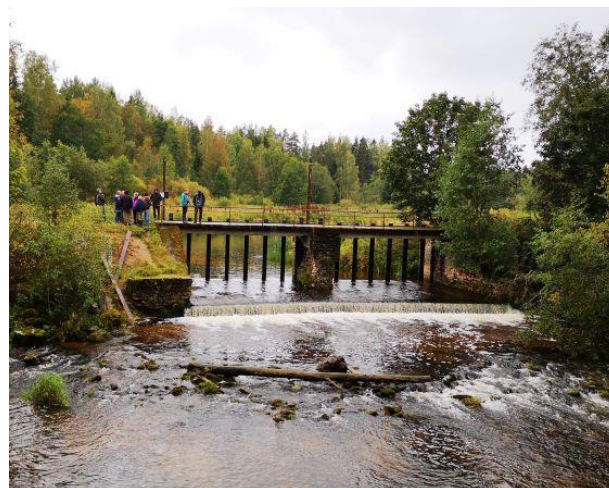
Kotka dam was built in 1950 and operated as hydropower station until 1960. After that it provided water for a fish farm. The dam broke down in 2016 and it was not restored because it has no water permit.

Characteristics: original height was 3,5 m and present height is 1,1 m, capacity 200 kW.

Photos 2 & 3. Kotka dam (S. Oisalu)

*Discussion on the site:* the main discussion on the site was related to the cost of different proposed solutions. Secondly, it is evident that several local people are not satisfied with a loss of the lake and it was discussed how to communicate the solutions better so that the local community would appreciate the activities.

1. The dam construction will be removed and 76 m artificial rapid will be created. Estimated cost is 390 456 euros.
2. The dam construction will be removed and only banks are enforced. Estimated cost is 72 600 euros.

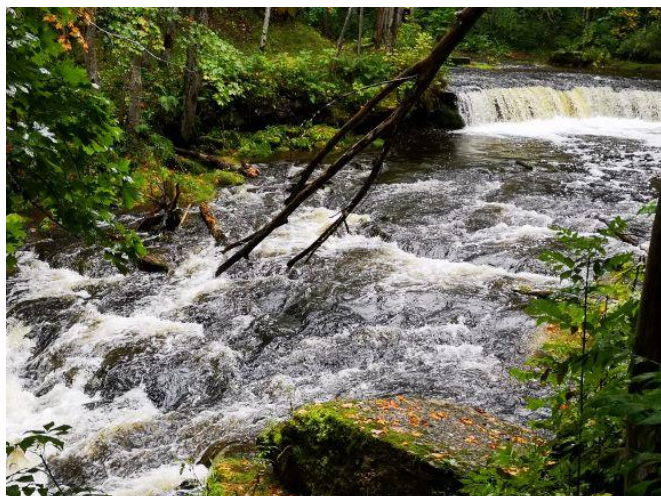
*Discussion on the site:* the site does not have major conflicting issues. The step under the bridge cannot be lowered because the bridge structures could become unstable.

Photo 4. Nõmmeveski waterfall (S. Oisalu)

In frame of the RETROUT project the plan is to build 30 m long artificial rapid downstream from the bridge, enforce banks and deepen the concrete bottom under the bridge. Estimated cost is 223 344 euros

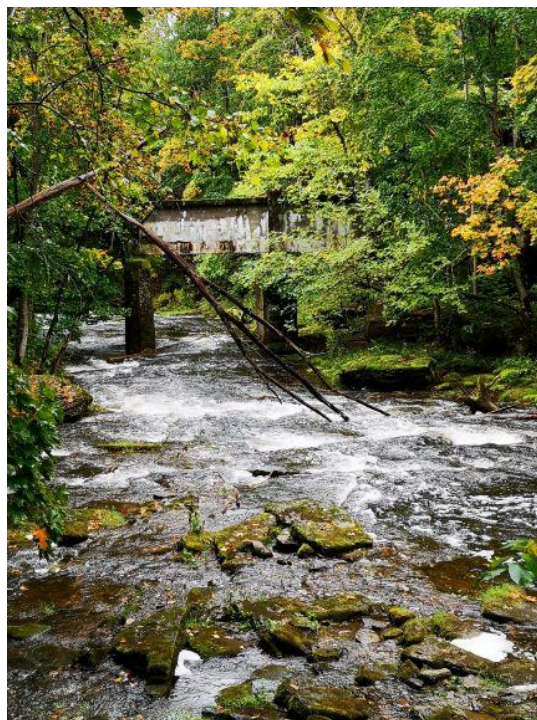
Nõmmeveski power station was built in 1924 and operated until 1964. The wooden components broke down in 2010. Characteristics: the remaining height of the dam is 1 m. Since 2000 current owners of the dam have tried to get water permit to restore the hydropower station.

Photo 5. Remains of Nõmmeveski hydropower station (S. Oisalu)

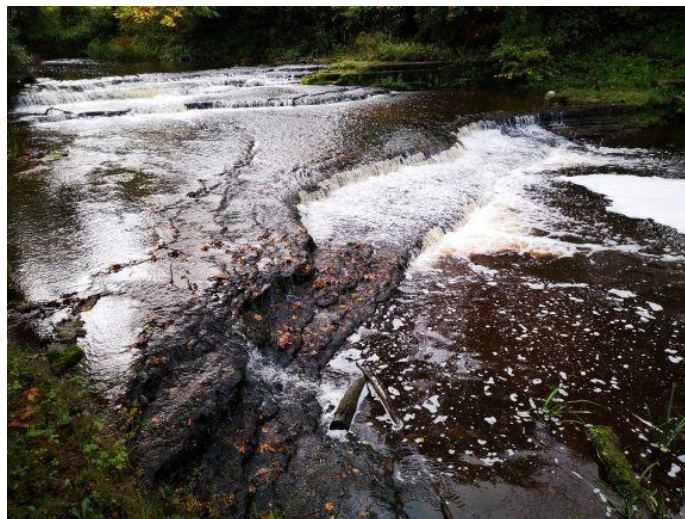
Joaveski hydropower station was built in 1898 to supply the newly built cardboard factory. Next to the factory is Joaveski cascade (160 m with six 1,1 m - 1,5 m waterfalls) that was created from 4 m waterfall when limestone was excavated directly from the river to build the factory. Production in the factory was ended in 1994. In 2001 new owners started hydropower production there.

Photo 6. Joaveski cascade (S. Oisalu)

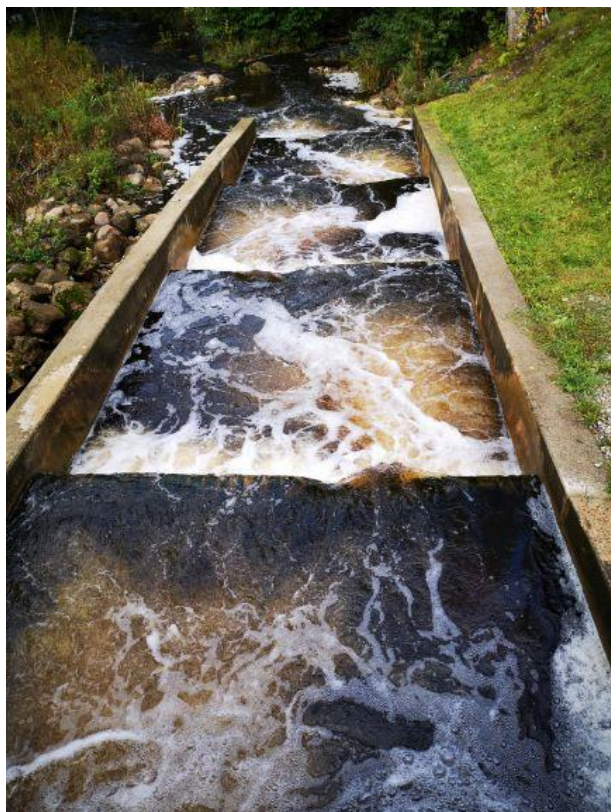
Photo 7. Joaveski fish pass (S. Oisalu)

In 2013 the fish pass was built which is a technical fish-pass with 5 pools. Each step of the fish pass is 0,45 m high. Characteristics: the height of the dam is 2,8 m. Cost of the fish pass was 165 681 euros.

1. The steps of the fish pass are too high and only good swimmers are able to pass it by jumping. There are no openings at the bottom of the pools.
2. Fish that migrate upstream are attracted to the turbine outlet channel if the HEP is working. The fence at the end of the turbine outlet channel is ineffective.

*Discussion on the site:* the main issue is whether such fish-pass is functional enough to ensure recovery of migrating fish populations and how to improve the situation from now on.

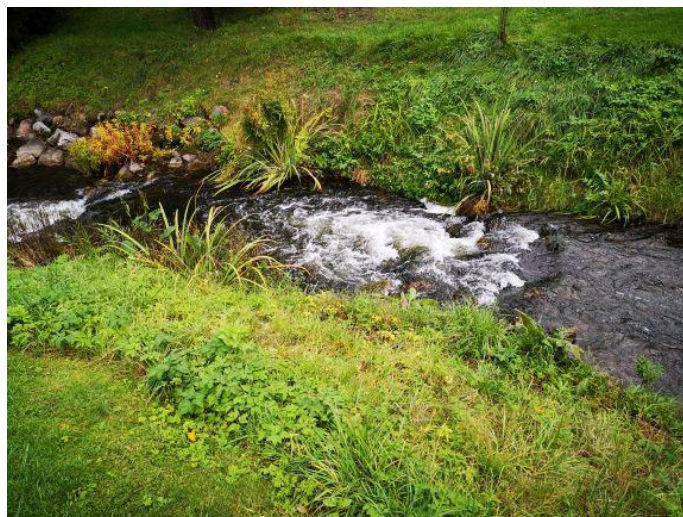
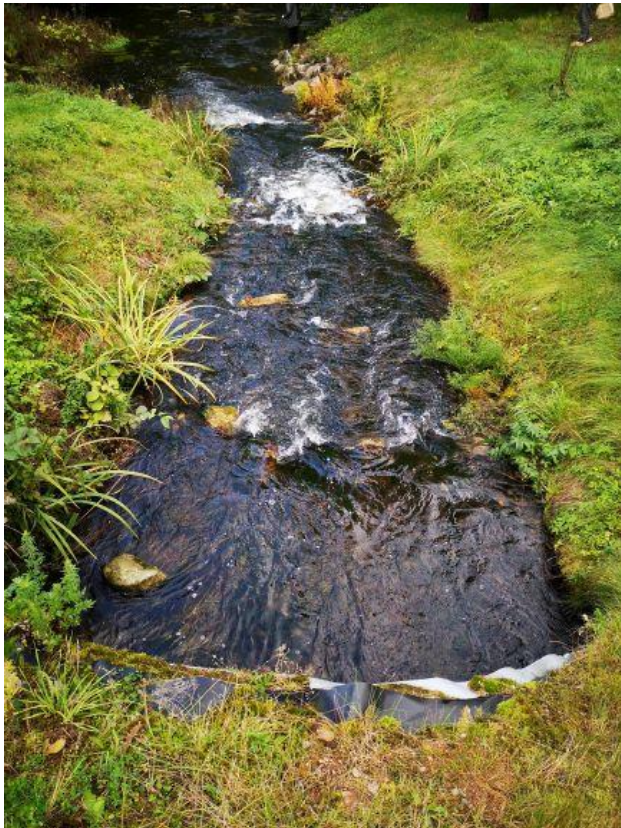
The fish pass on Arbavere dam is the first natural like fish pass built in Estonia. It was constructed in 2011. Characteristics: length of the fish pass is 120 m and the height is 2.5 m. Cost of the fish pass was 304 000 euros. Note! The cost contained also a fish counter that alone costs about 50 000 euros.

Photo 8. Arbavere fish pass (S. Oisalu)

Photo 9. Arbavere fish pass (S. Oisalu)

1. Natural like fish pass is passable for all fish species in river both direction. The fish pass serves as a habitat for juvenile trout and other fish species.
2. Most of the flow is directed through the pass and that ensures that the migrating fish find the fish pass entrances.
3. Location of the lower fish pass entrance is close to the dam and is therefore easy to find.

The only negative aspect of such fish passes is that it takes up more space than other fish pass types. This means that such fish passes cannot be built in for example steep valleys.

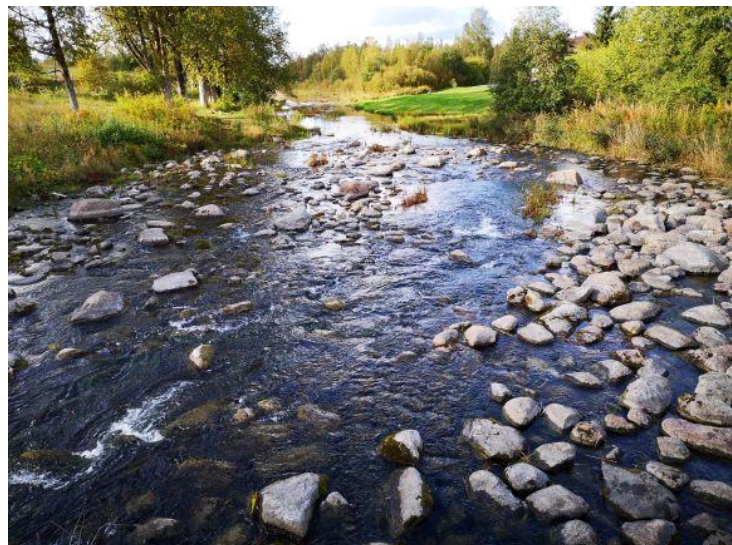
Tapa dam was 1,2 m high and thus impassable migration barrier for most fish species. To ensure free passage for fish, the dam was demolished and a natural-like rapid was built instead. The rapid provides free passage for all fish in both directions. The rapid is also a habitat for juvenile trout. Cost of the fish pass is not available.

*Discussion on the site:* participants of the study visit concluded that the solution is a good example and all fish can pass the site freely.

Photo 10. Tapa natural-like rapid (S. Oisalu)

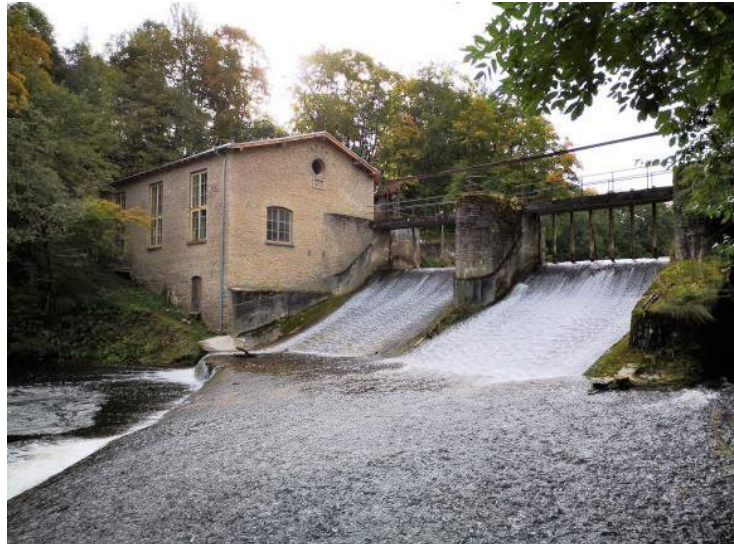
Kunda lowermost hydropower station was built in 1893 and at present it is not operational. Characteristics: designed height was 9,3 m, now approximately 6,5 m. The dam has no water permit and fish passage is obligatory.

*Discussion on the site:* the site is located in a step valley and thus all activities are technically complicated.

Photo 11. Kunda lowermost hydropower station (S. Oisalu)

RETROUT project will provide plans how to remove the dam in a way that the cultural value is least affected. This work is currently in process.

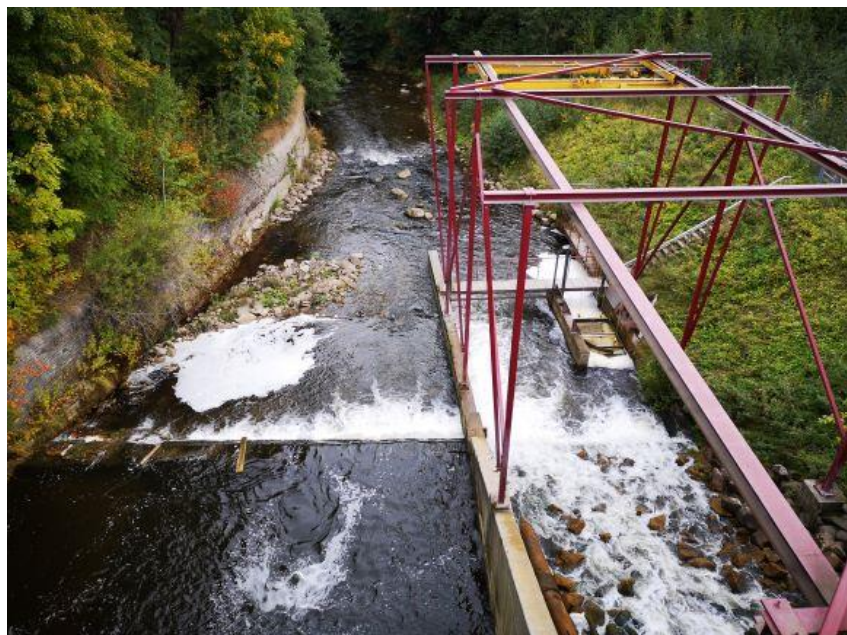
Kunda second hydropower station was built in 1870 and rebuilt in 2003. Characteristics: height is 6,4 m. The dam has no water permit and is not operational. The fish lift was built in 2013. Total cost 538 799 euros! State subsidy was 295 592 euros.

1. The effectiveness of providing upstream passage is highly questionable.
2. Downstream migration is problematic. There is a high probability that the smolts enter the turbines.

*Discussion on the site:* participants of the study visit agreed that such fish lift is clearly ineffective and very expensive. In the future such solutions should be avoided.

Photo 12. Fish lift on Kunda river (S. Oisalu)

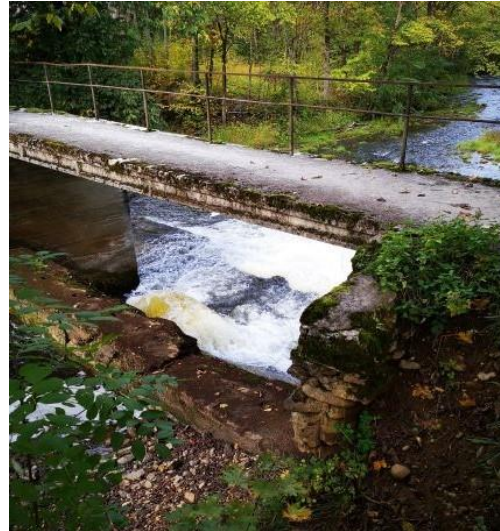
The old Kunda manor mill was built in 1870 and the original height was 2,7 m. The dam is in ruins and the plan is to demolish it.

*Discussion on the site:* all participants of the study visit agreed that the best option would be to remove the concrete body of the dam and to give the site as natural appearance as possible.

Photo 13. Dam of the old Kunda manor mill (S. Oisalu)

RETROUT project will provide plans how to remove the dam. This work is currently in process.

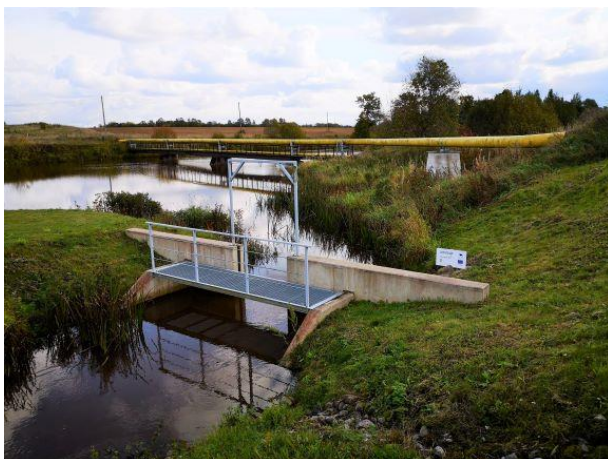
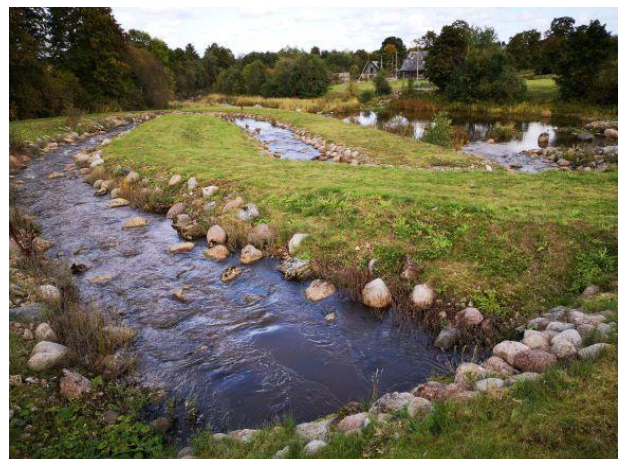
Photos 14 & 15. Sillaoru fish pass (S. Oisalu)

Sillaoru hydropower station has capability of ca 300 kW. The natural like fish pass was built in 2014. The fish pass is 175 m long and elevation is 3,5 m. The cost of the fish pass was 187 474 euros.

1. Fish that migrate upstream are attracted to the turbine outlet channel if the HEP is working. The fence at in the end of the turbine outlet channel is ineffective.
2. Downstream migration is problematic. There is a high probability that the smolts enter the turbines.

*Discussion on the site:* most of the discussion was about the location of the fish pass and what should have been done differently or how to improve the effectiveness of the present fish pass. Adding more water to the original river channel would attract more fish towards the fish pass and that would in all likelihood improve the upstream passage.
